# Manhole Inspection Summary

Manhole # S31GG\_036MH

Insp Date: **1/16/07 10:24 AM**

**Location** Address: **209 LANVALE ST**

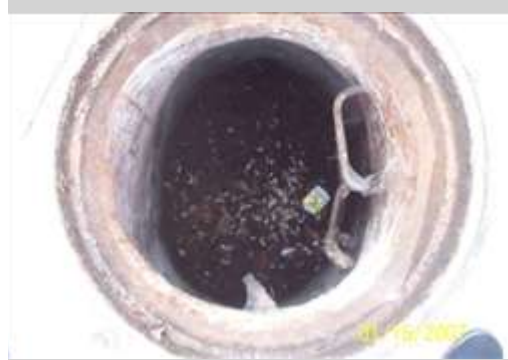
Top View

Channel debris. Corroded steps.

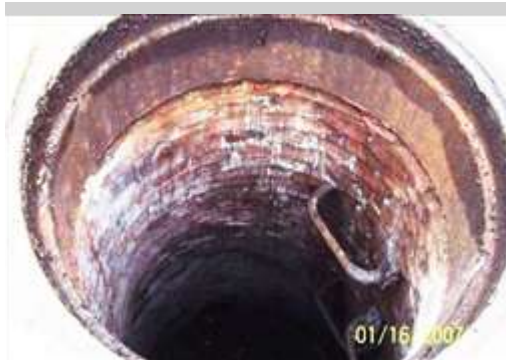
Defect

Adjustment deterioration and infiltration.  
Corbel and Barrel infiltration.

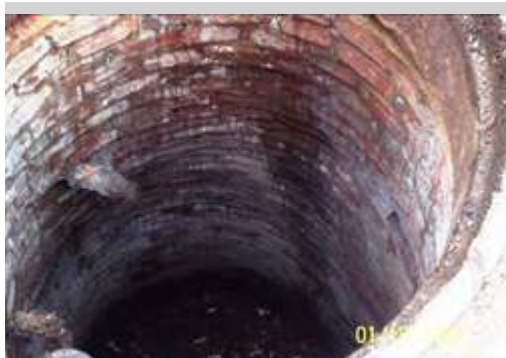
Defect

Adjustment, Corbel and Barrel infiltration.

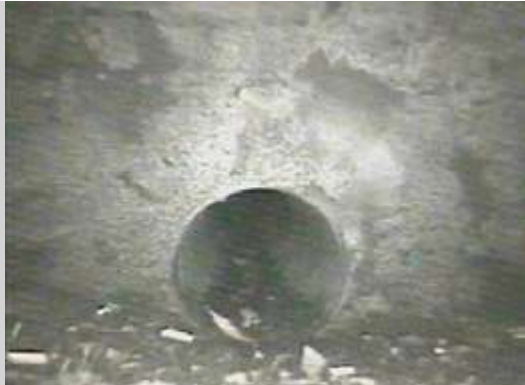
8 in. Circular Gravity Sewer  
Pipe Out @ 12 O'Clock

Deposits: ☐ None ☒ **Mud** ☐ Sludge ☒ **Debris** ☐ Grease

Silt Depth: **0.5** (in.) Deposits Extent: **Light**

Infiltration: **Evidence** Pipe Seal Cond: **Unknown**
